YOUR ONESURVEY  
**HOME REPORT**

4a Garnock Street  
Dalry  
KA24 4BT

# Document Index

# Single Survey

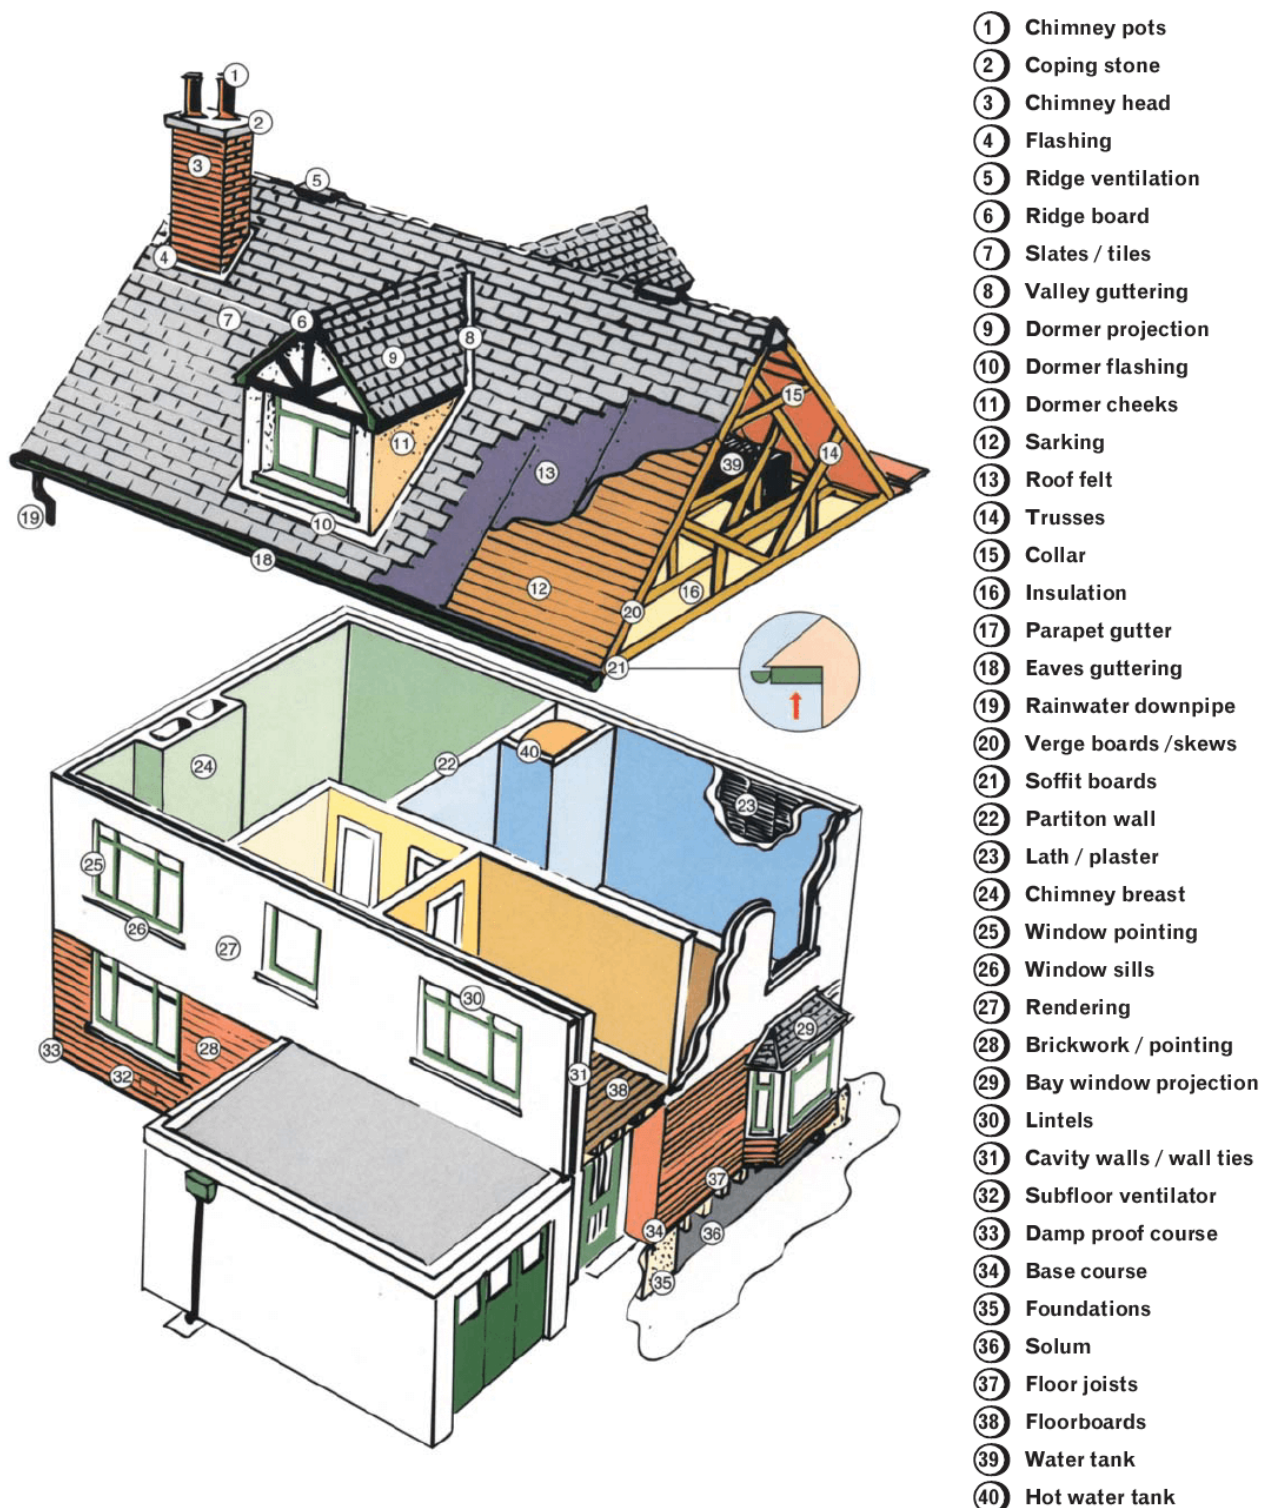
## Sectional Diagram showing elements of a typical house

Reference may be made in this report to some or all of the above component parts of the property. This diagram may assist you in locating and understanding these items.

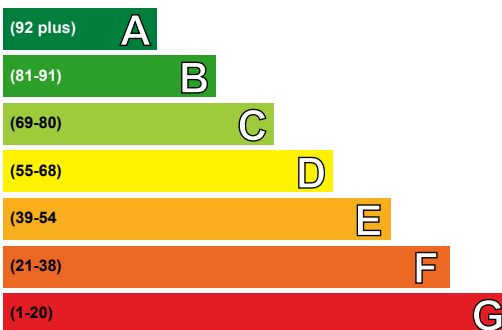
Very energy efficient - lower running costs

Not energy efficient - higher running costs

The potential rating shows the effect of undertaking all of the improvement measures listed within your recommendations report.

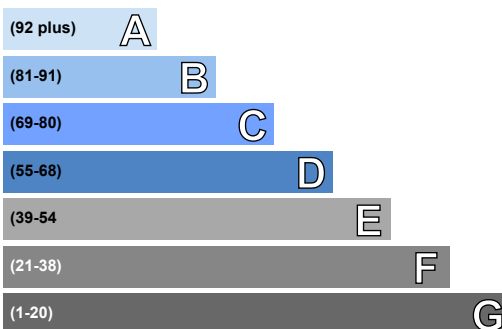
Very environmentally friendly - lower CO<sub>2</sub> emissions

Not environmentally friendly - higher CO<sub>2</sub> emissions
